Exhibit Summary

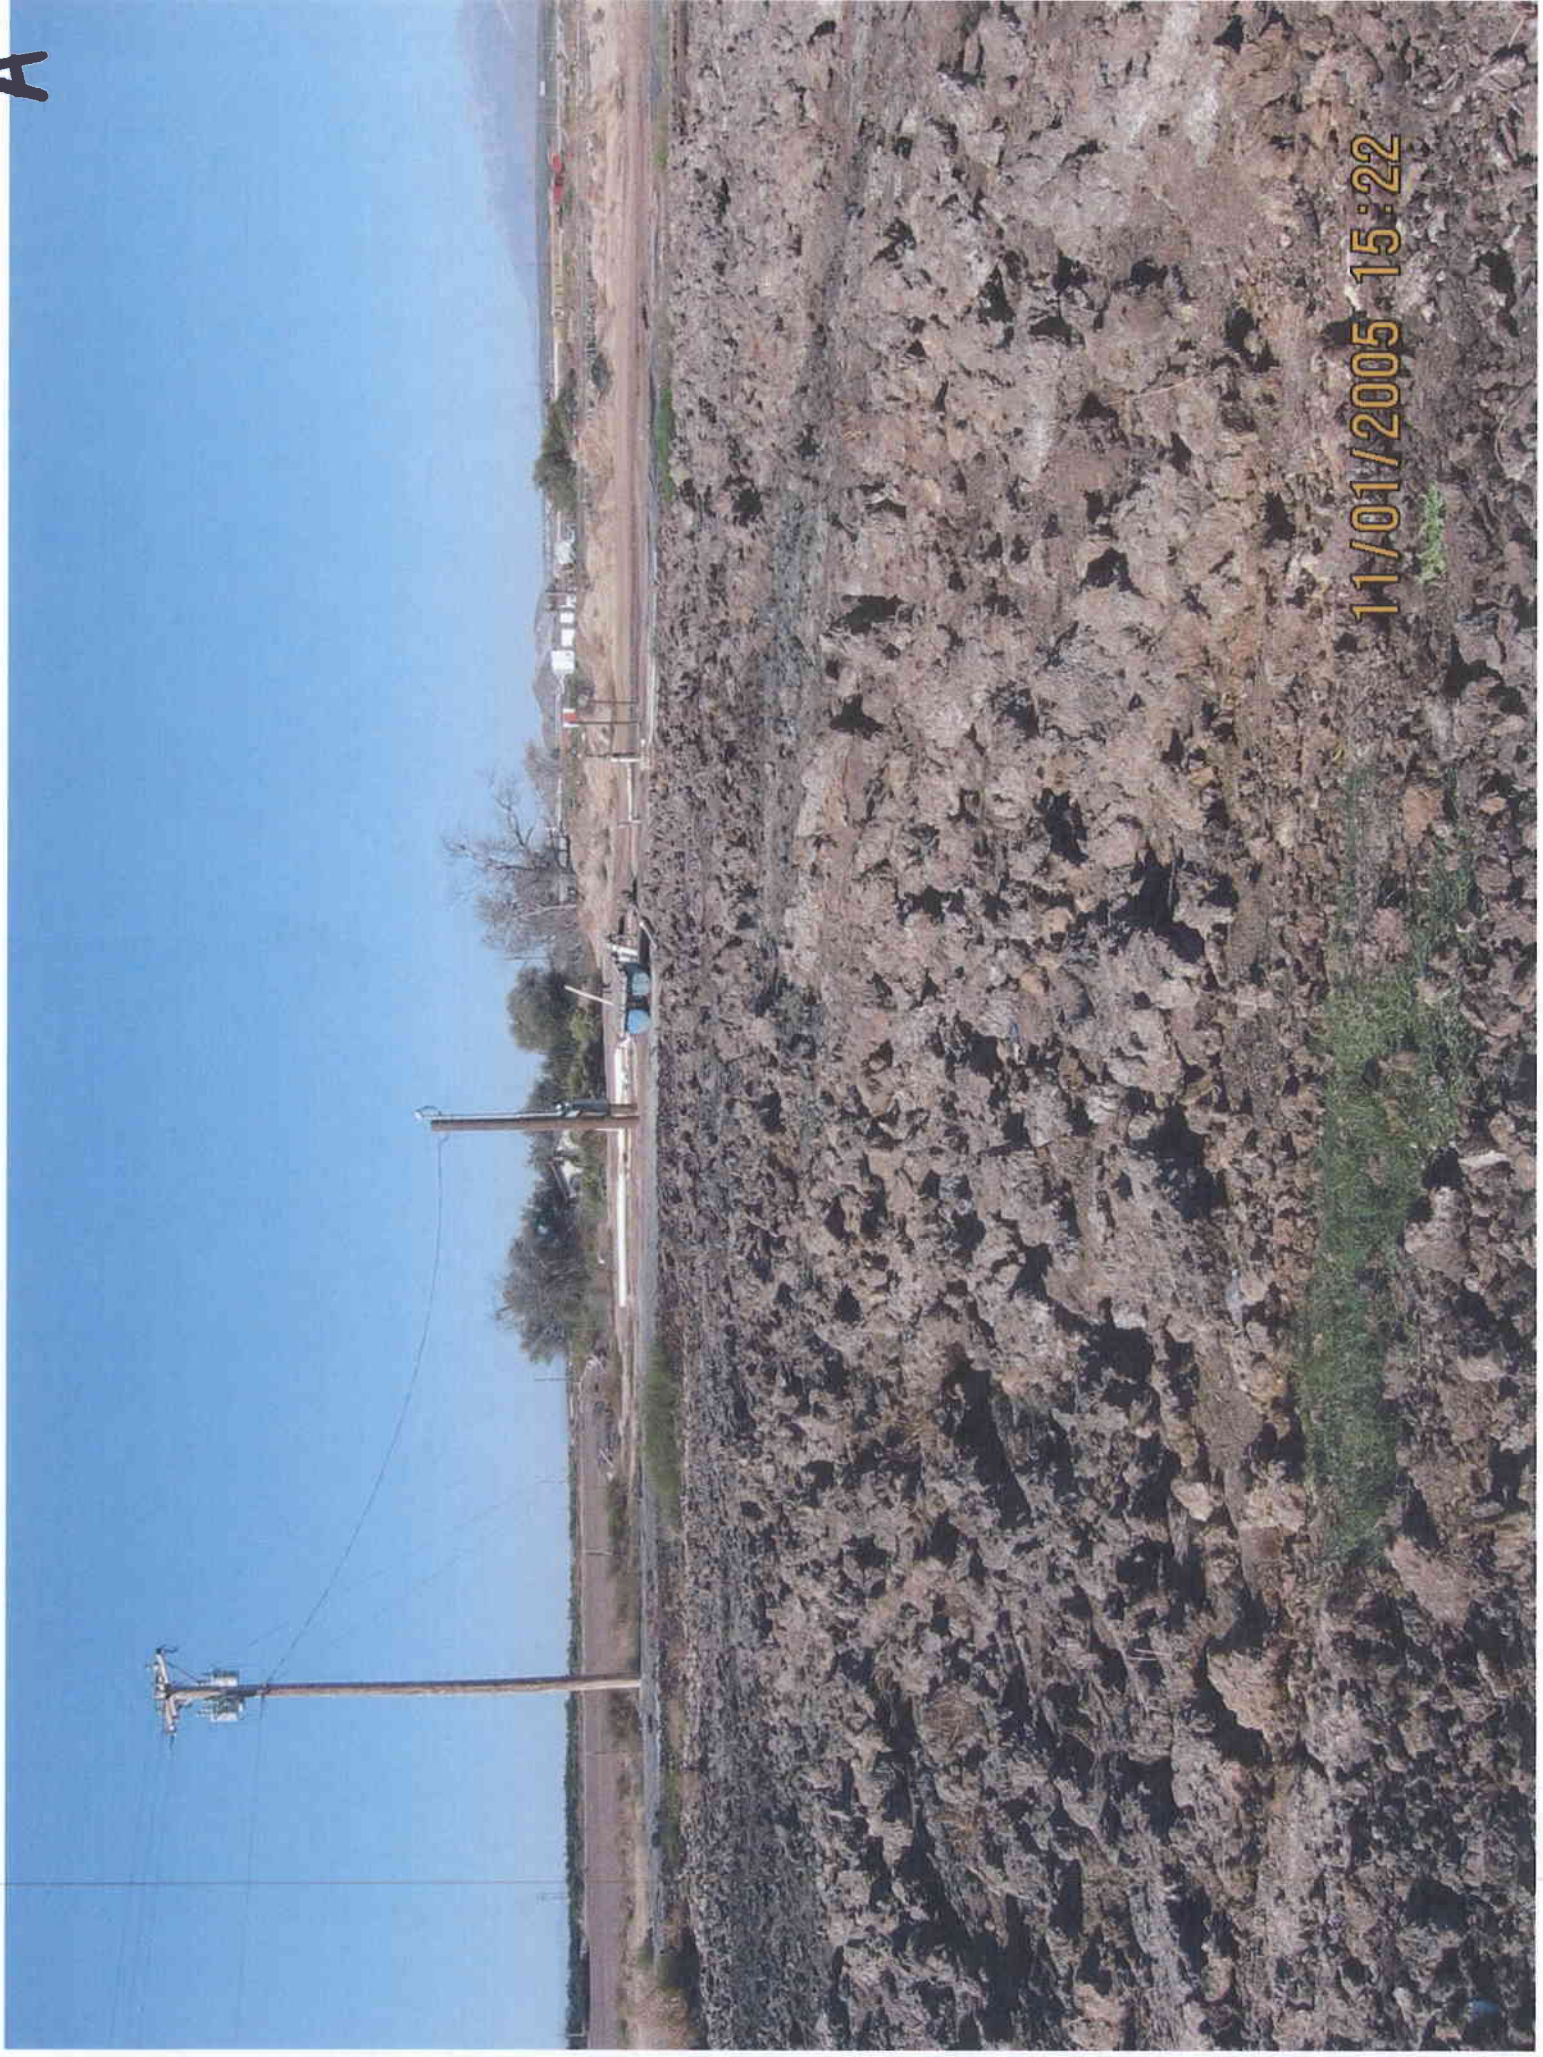
Picture A shows a wastewater impoundment with excessive manure solids. This picture was taken at a dairy facility with a manure solids settling separator. Wastewater flows from the parlor through the separator, to the pictured wastewater impoundment, prior to being land applied. [Desertland Dairy, DP-260, 11/01/05]

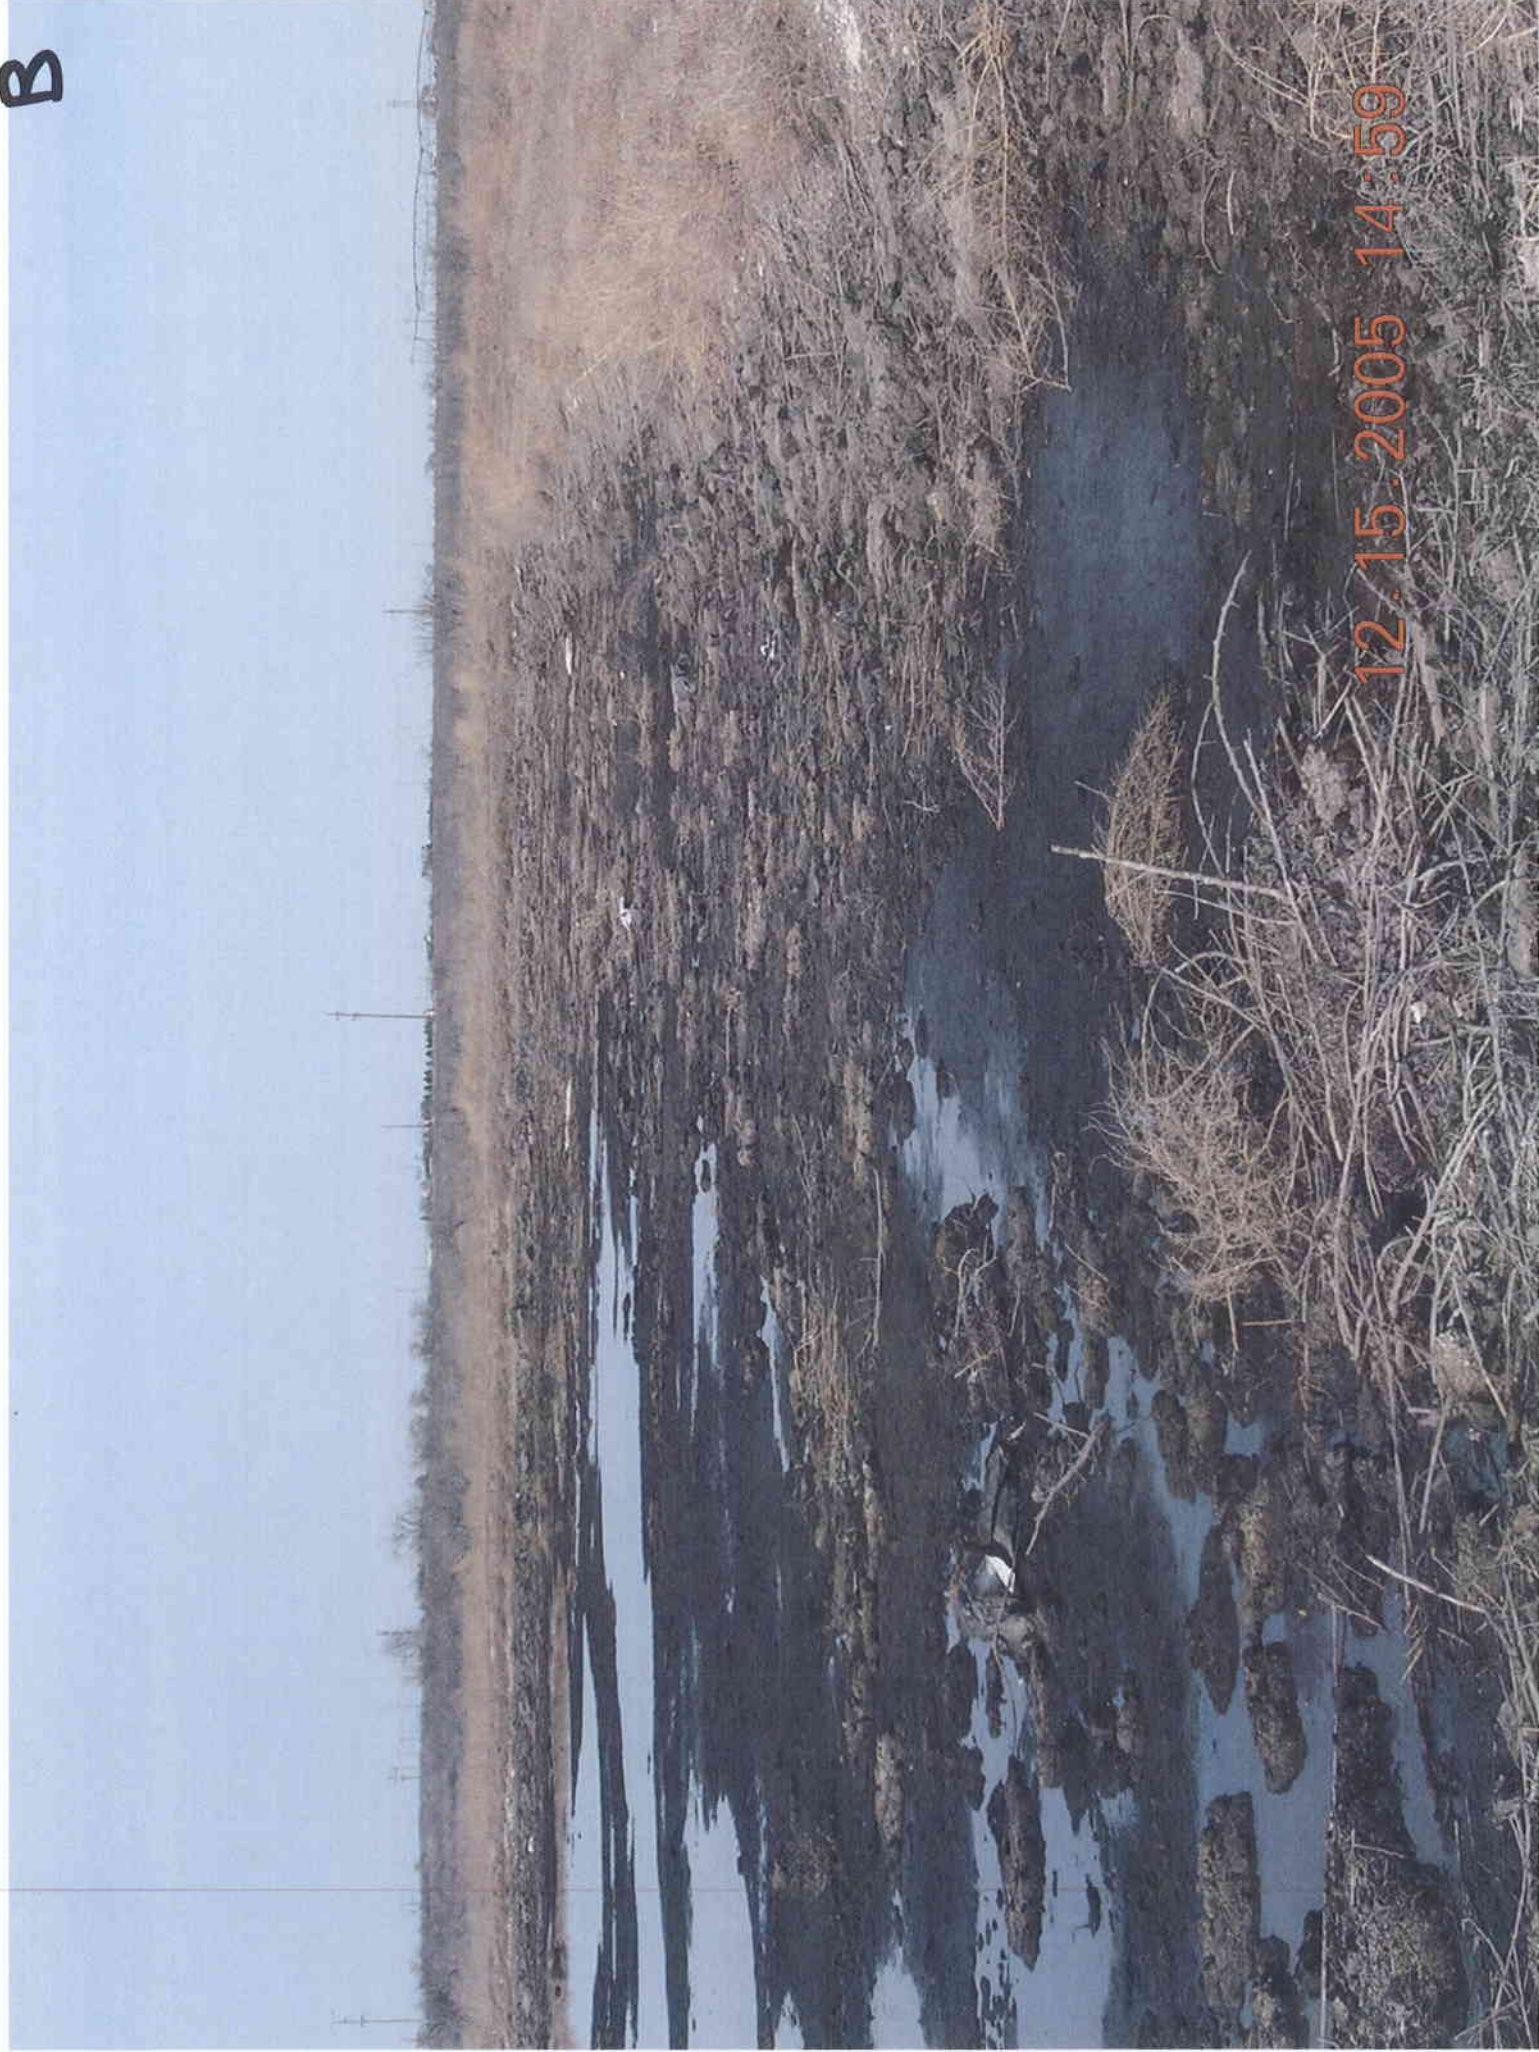
Picture B shows a wastewater impoundment with excessive manure solids. This picture was taken at a dairy facility with a single, concrete manure solids settling separator. Wastewater flows from the parlor through the separator and is pumped to the pictured wastewater impoundment, prior to being land applied. [Faria Dairy, DP-923, 12/15/05]
